The Calcutta Gazette

WEDNESDAY, MAY 31, 1922.

NOTICES TO MARINERS.

P. G. GLANVILLE, COMMANDER, R.I.M.,
Deputy Port Officer of Calcutta.

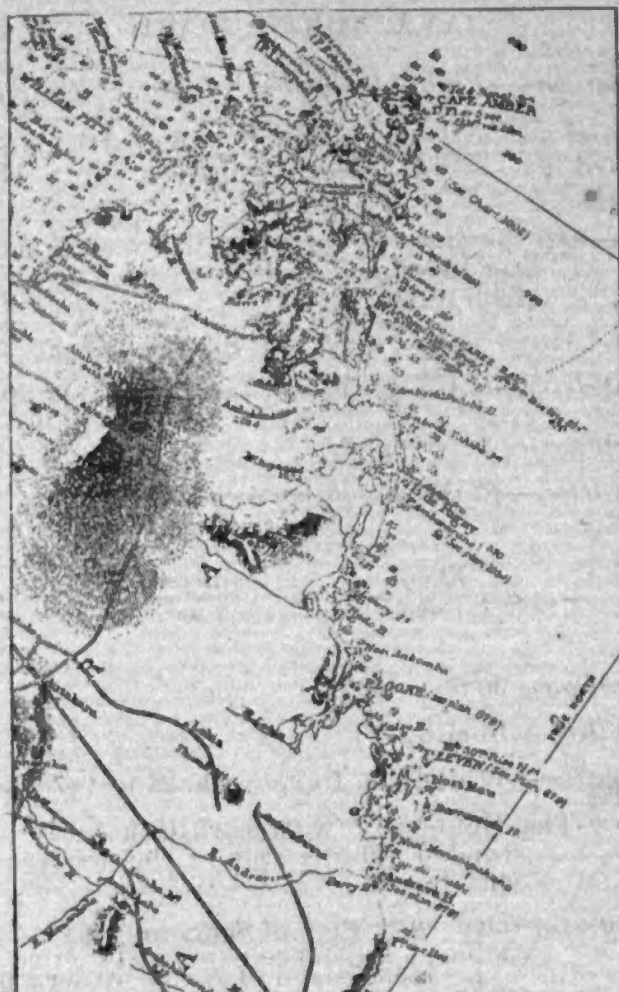
Reproduction of Portion of Chart N° 758.

Details.—General amendments to charts Nos. 758, 2762, 2899 and 597 with regard to the coast of Madagascar and offlying shoals and depths, between Cape Amber and Andrava bay, are shown on the accompanying reproductions of portions of those charts.

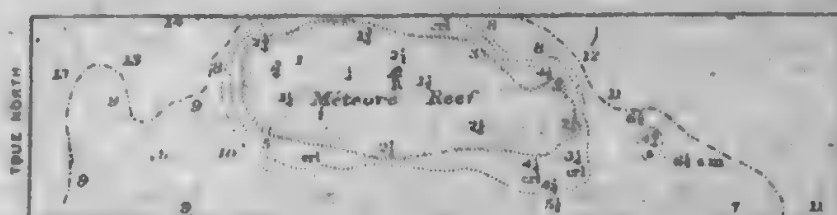
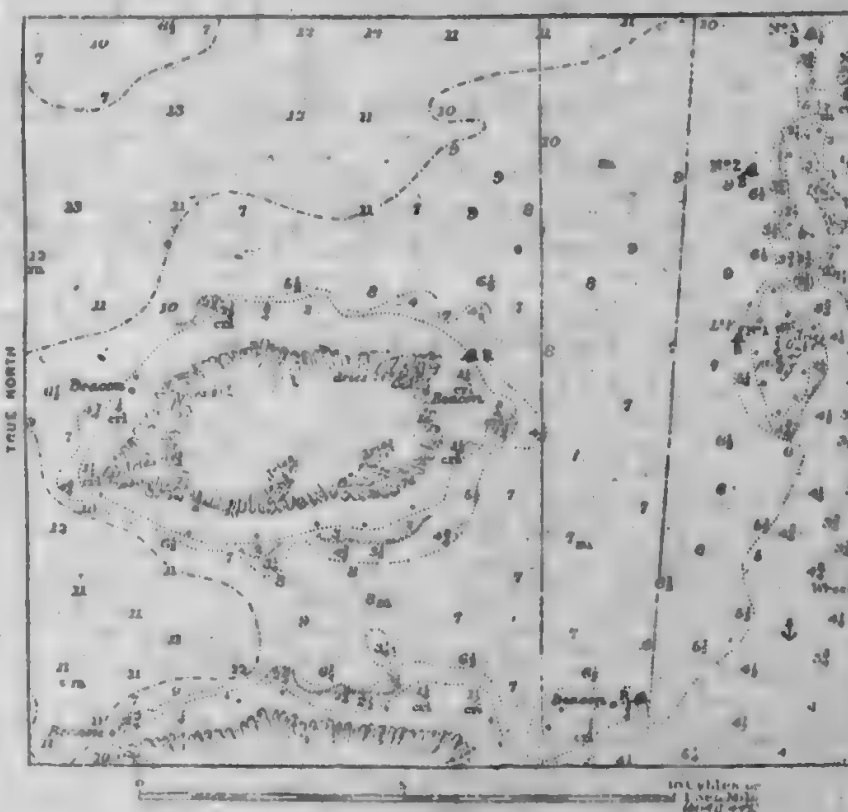
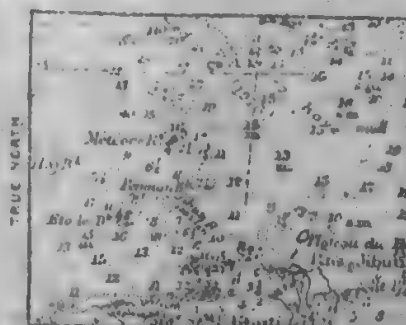
Reproduction of Portions of Chart No. 253.

2. The buoys formerly marking Penguin and Etoile banks also the white can buoy formerly marking the shore bank northward of Plateau du Héron have been withdrawn and are to be expunged from the charts.
3. The black can buoy situated about 2½ miles westward of Mashah lighthouse has been replaced by a black bell buoy.

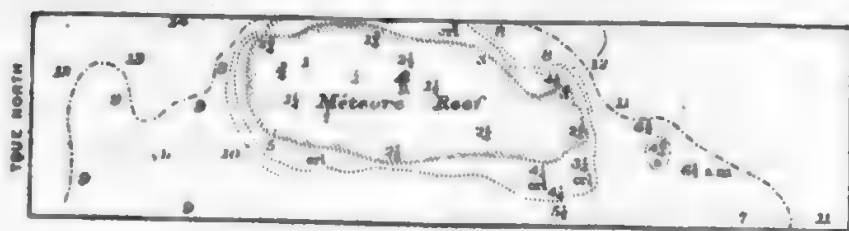
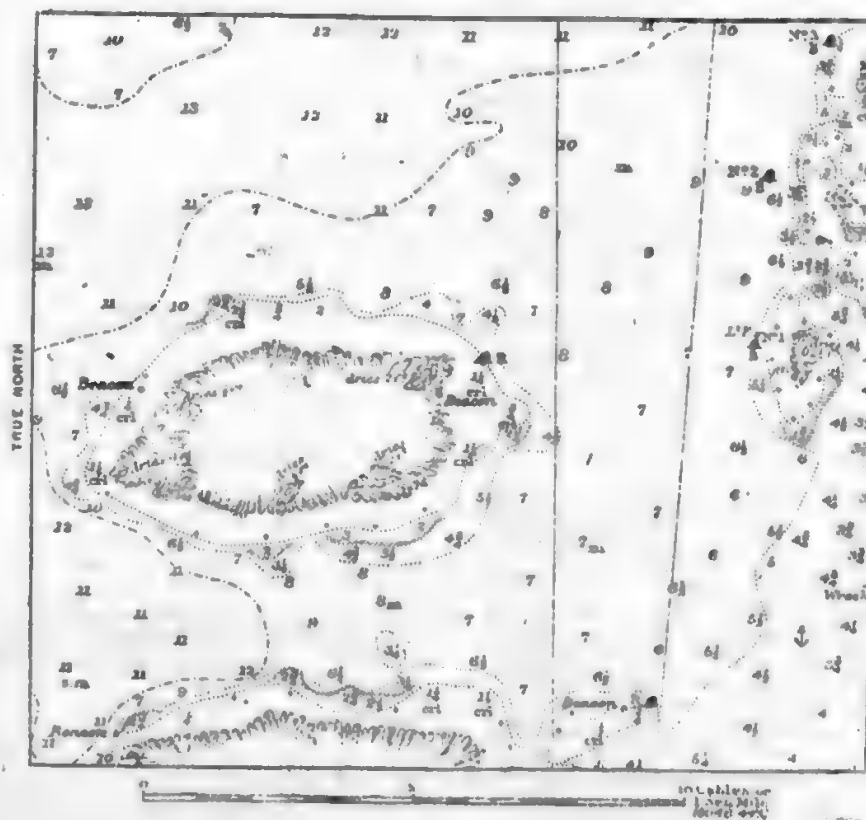
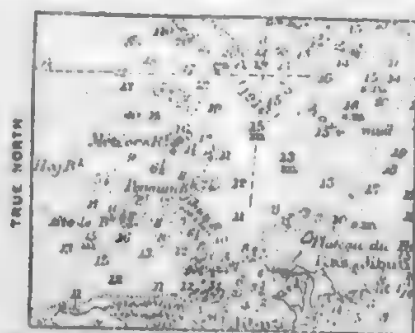
Reproduction of Portions of Chart No. 253.

2. The buoys formerly marking Penguin and Etoile banks also the white can buoy formerly marking the shore bank northward of Plateau du Héron have been withdrawn and are to be expunged from the charts.
3. The black can buoy situated about 2½ miles westward of Mashah lighthouse has been replaced by a black bell buoy.

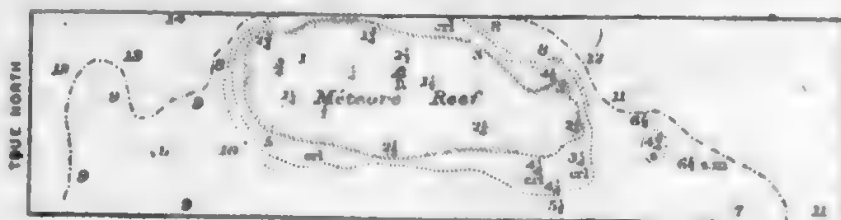
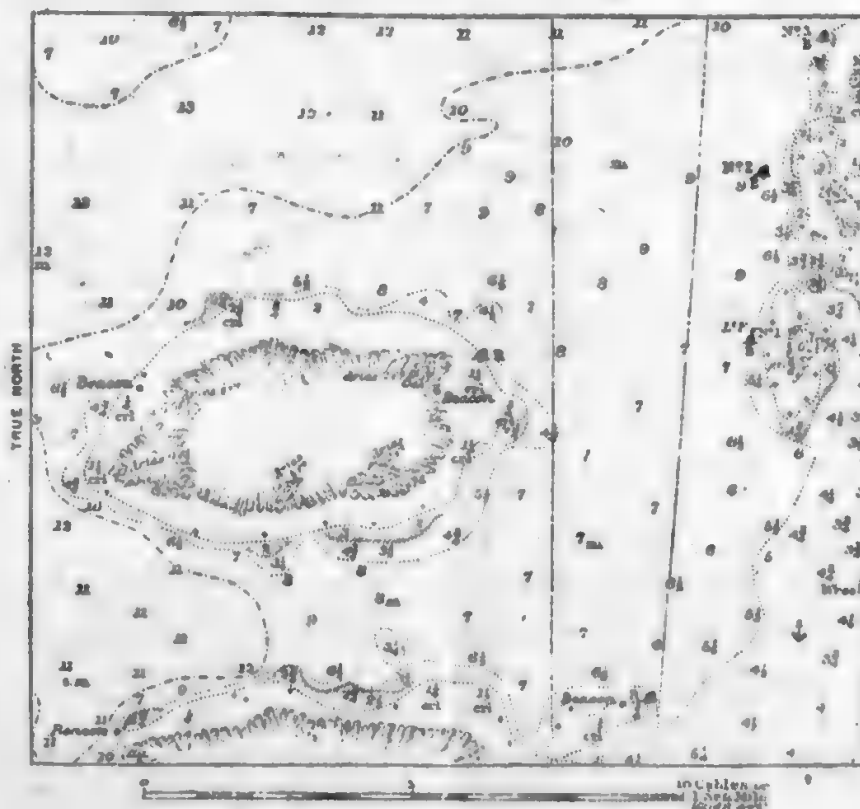
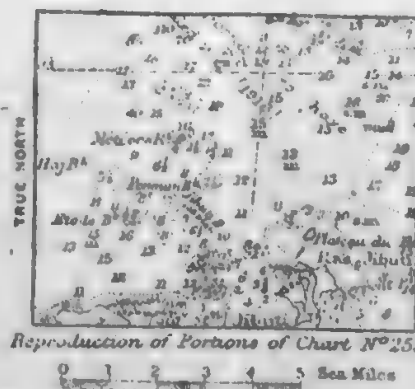
Reproduction of Portions of Chart No. 253.

2. The buoys formerly marking Penguin and Etoile banks also the white can buoy formerly marking the shore bank northward of Plateau du Héron have been withdrawn and are to be expunged from the charts.
3. The black can buoy situated about 2½ miles westward of Mashah lighthouse has been replaced by a black bell buoy.
